# Sunshine Terrace Condominiums

## Windstorm Mitigation Report

As of 01-15-2026 | FPAT File# MUD2526139

## Windstorm Mitigation Report (OIR-B1-1802)

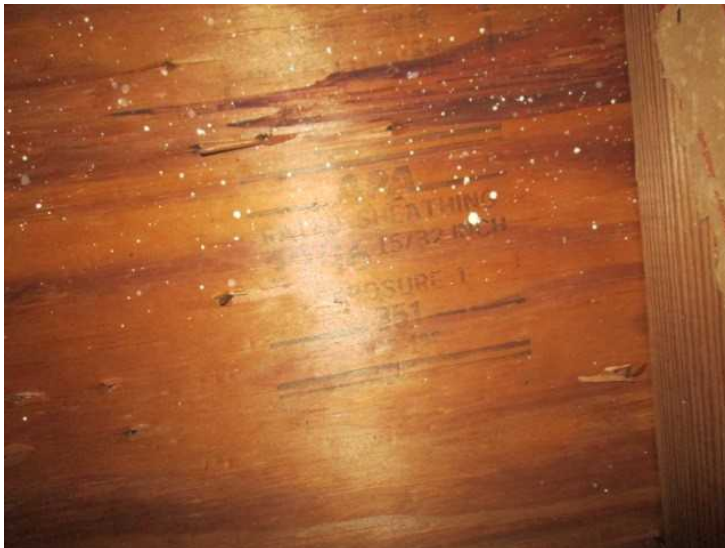
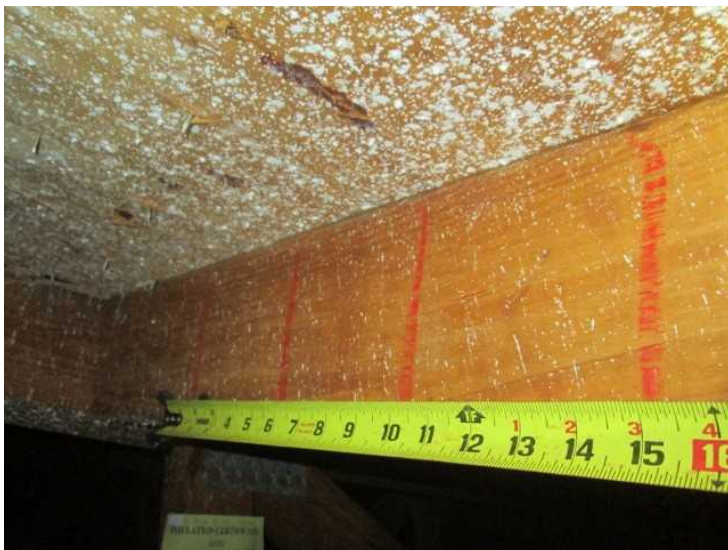
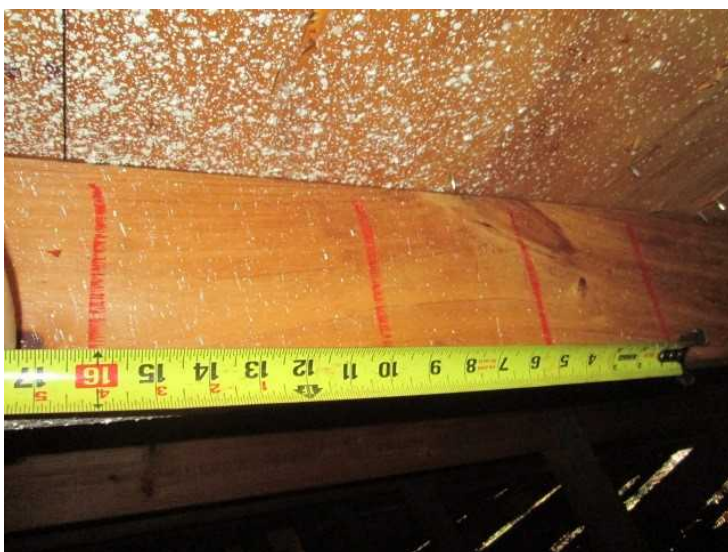
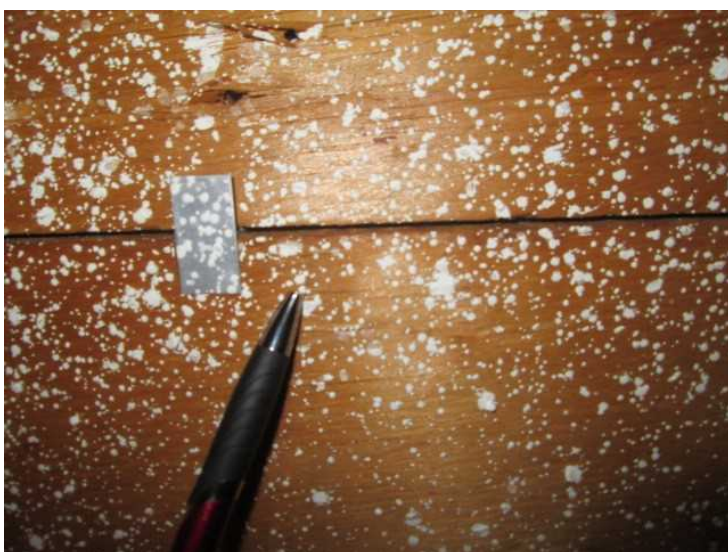
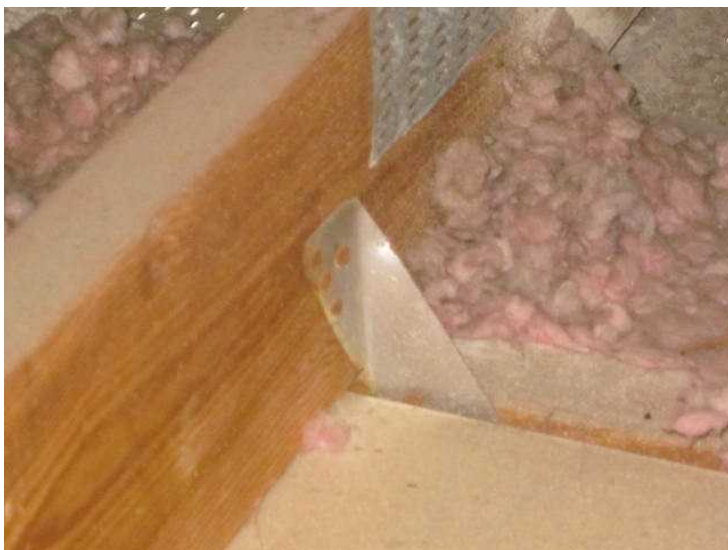
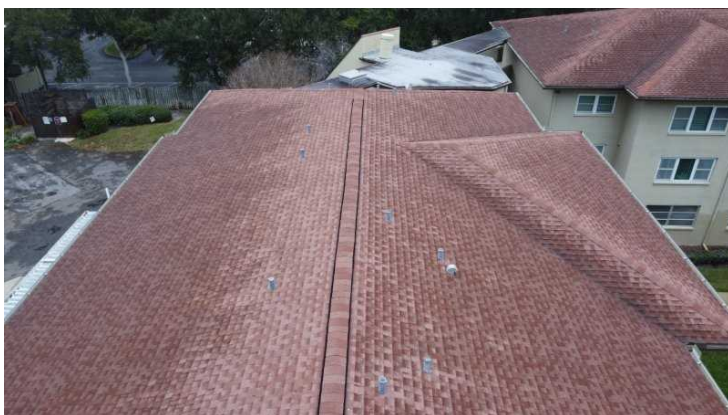
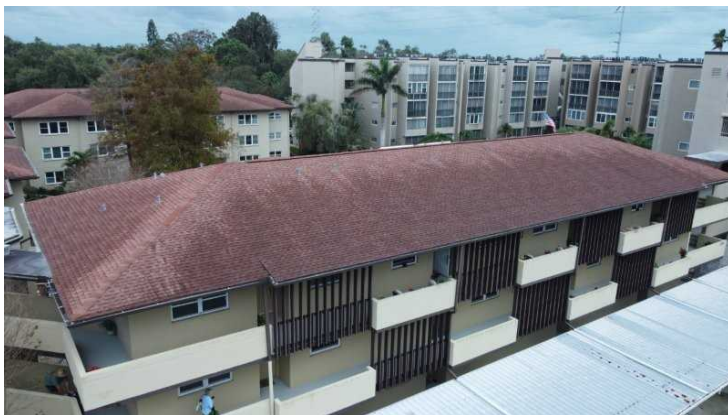
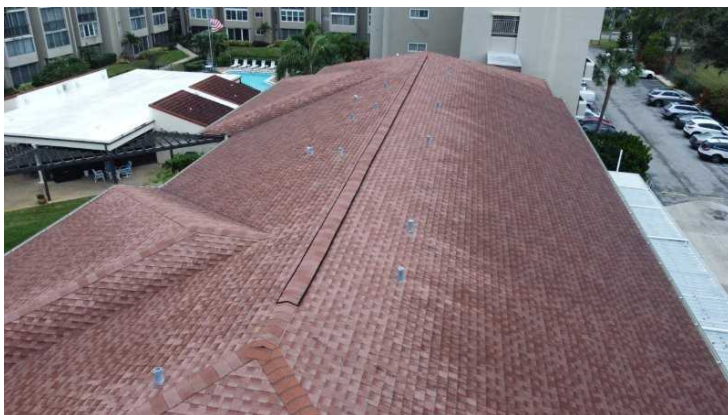
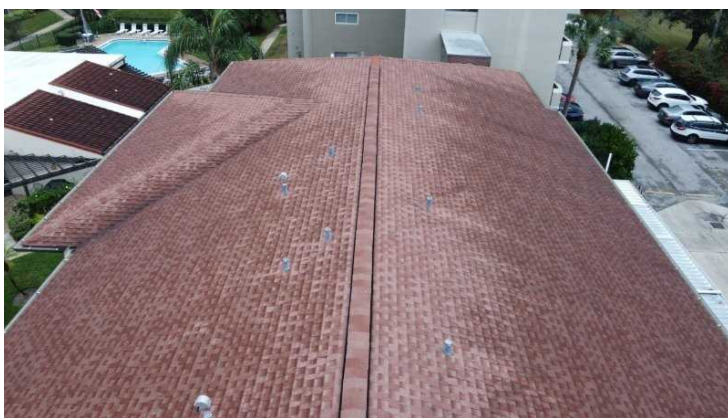
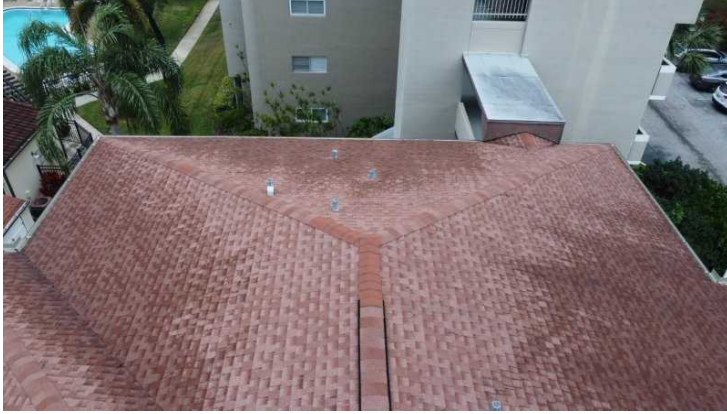
- 3. Roof Deck Attachment:** **Level C**  
Comments: Inspection verified 1/2" plywood roof deck attached with 8d nails at a minimum 6" on the edge & 6" in the field.

- 4. Roof to Wall Attachment:** **Clips**  
Comments: Inspection verified hurricane clips fastened with a minimum of three nails.
- 5. Roof Geometry:** **Hip Roof**  
Comments: Inspection verified a hip roof shape.

- 6. SWR:** **Yes**  
Comments: SWR was verified at time of inspection. The Secondary Water Resistance verified is a self-adhering peel and stick.
- 7. Opening Protection:** **None or Some Glazed Openings**  
Comments: No opening protection verified at the time of inspection.

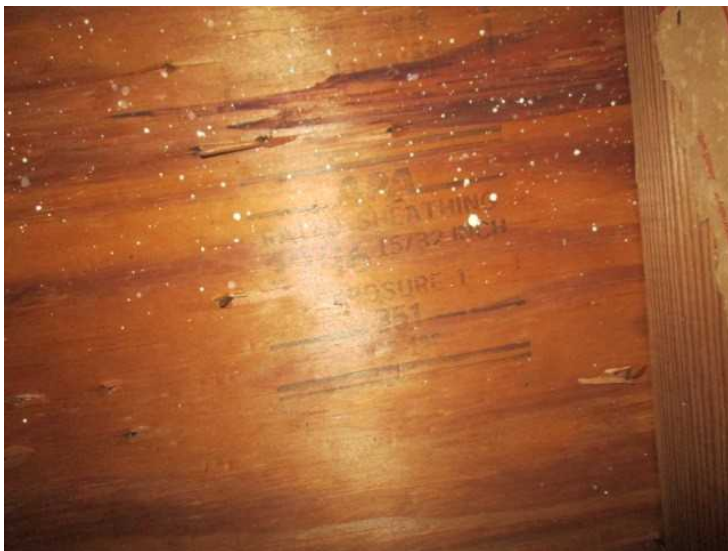
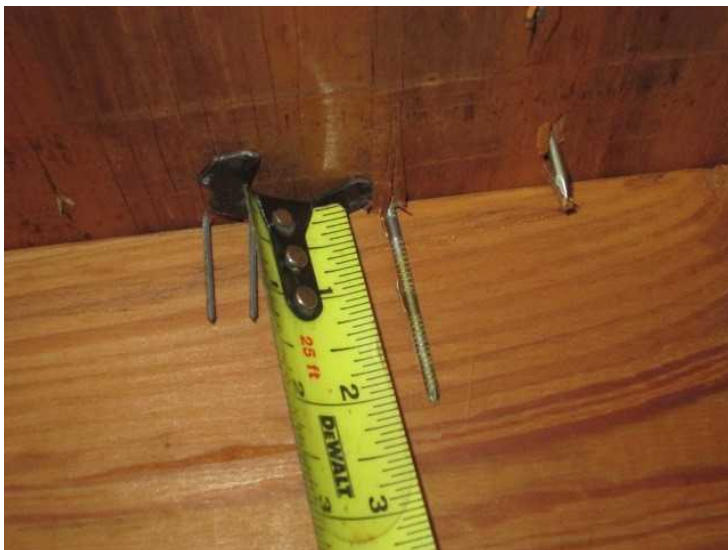
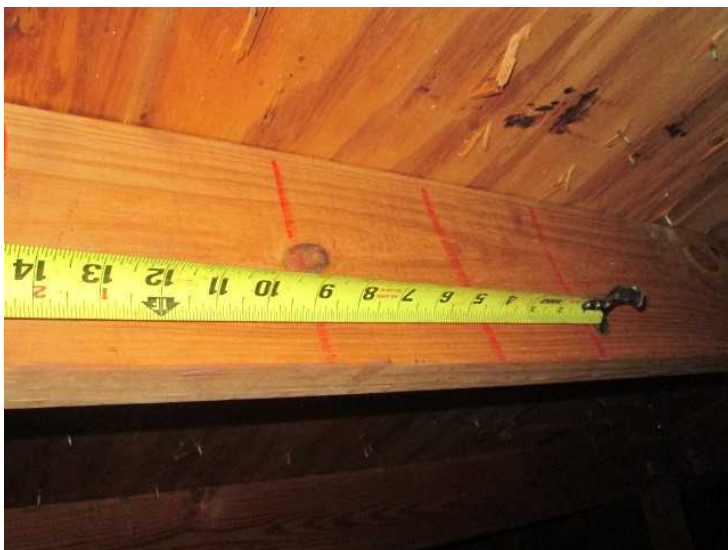
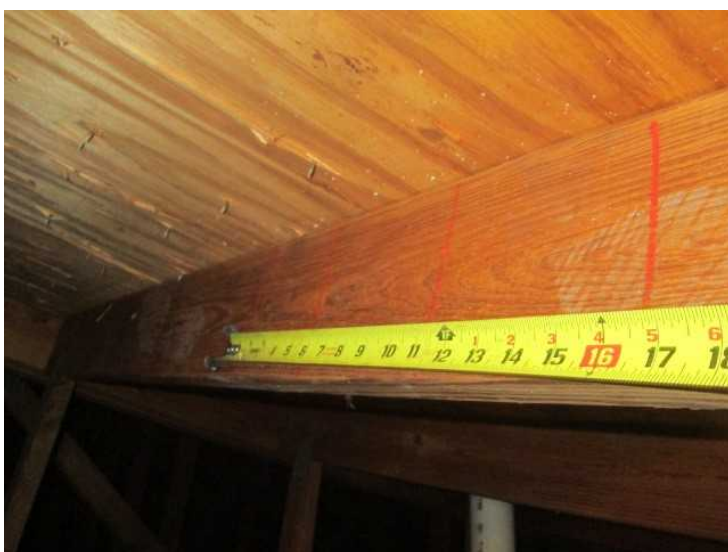
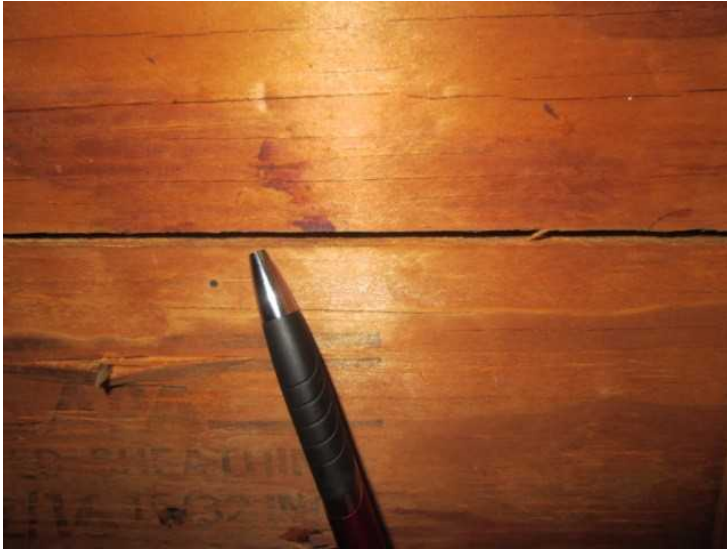
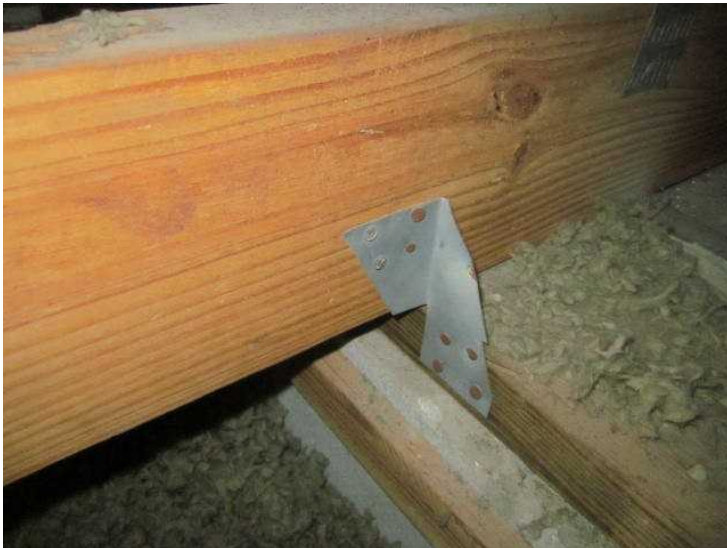
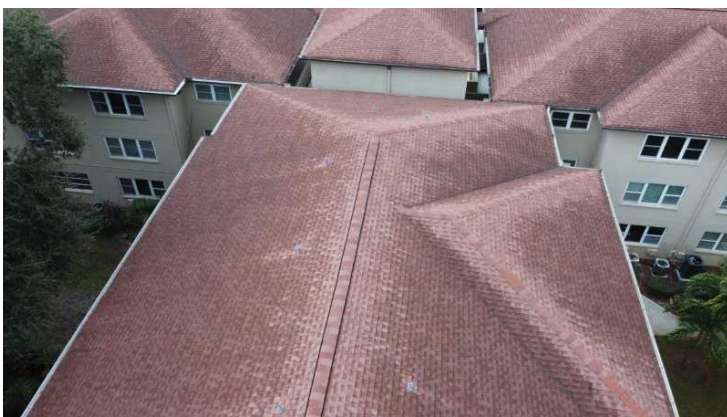
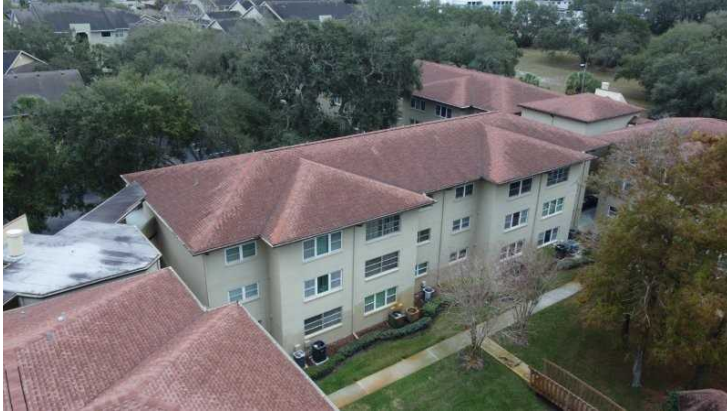
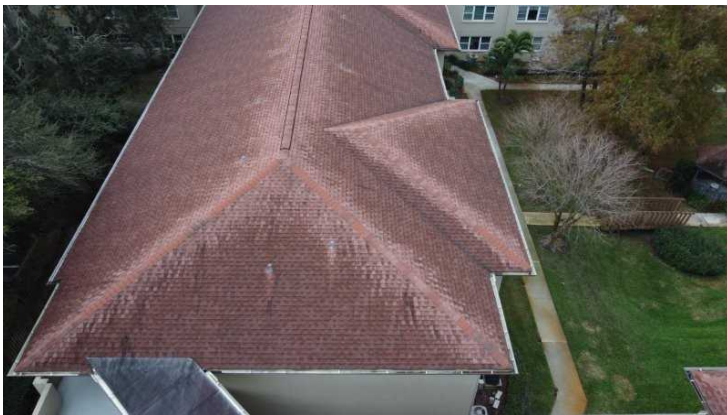
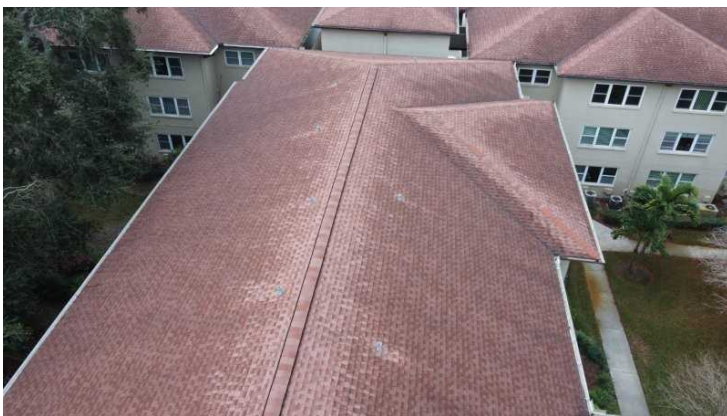
- 6. SWR:** **Yes**  
Comments: SWR was verified at time of inspection. The Secondary Water Resistance verified is a self-adhering peel and stick.
- 7. Opening Protection:** **None or Some Glazed Openings**  
Comments: No opening protection verified at the time of inspection.

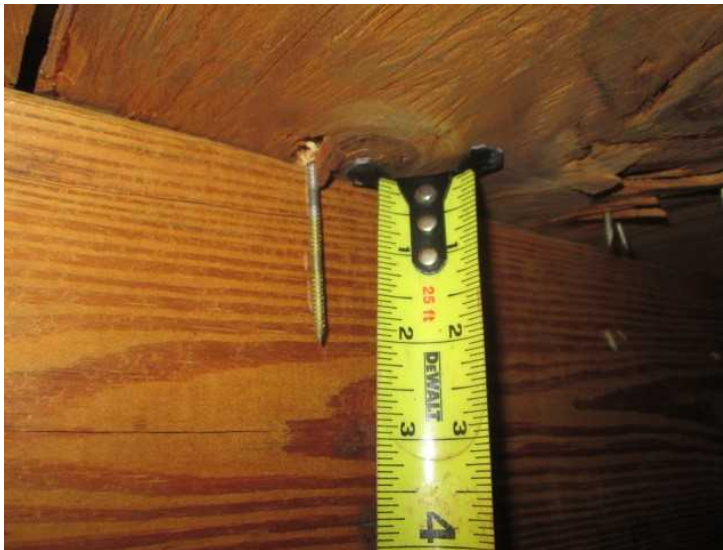
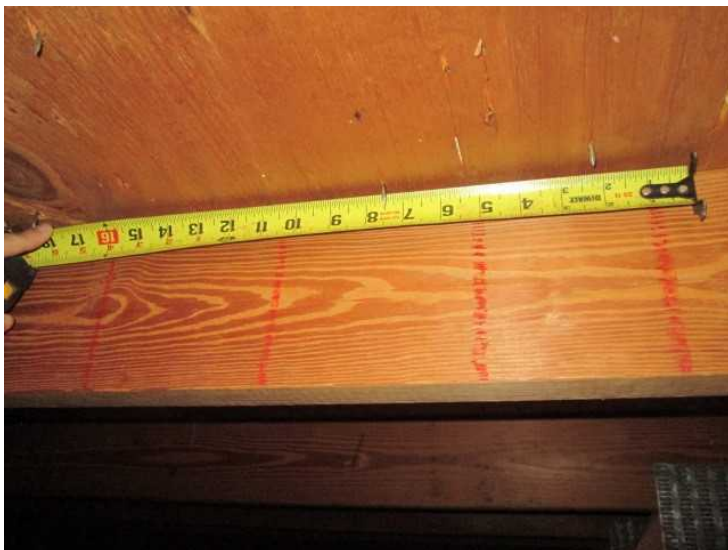
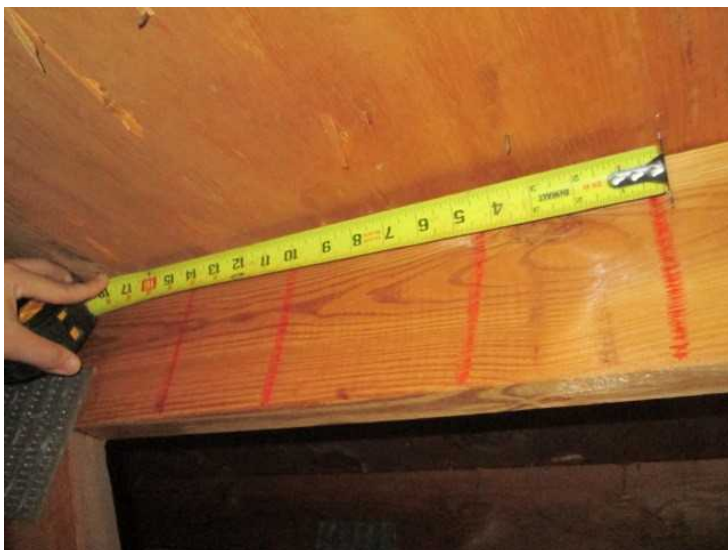
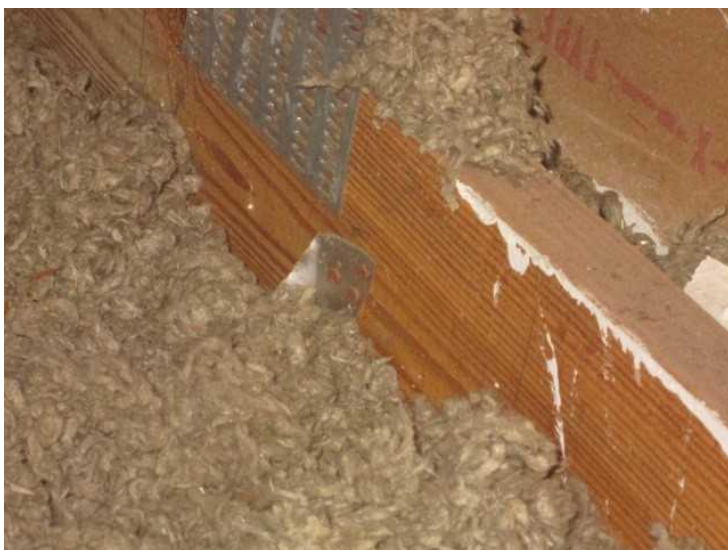
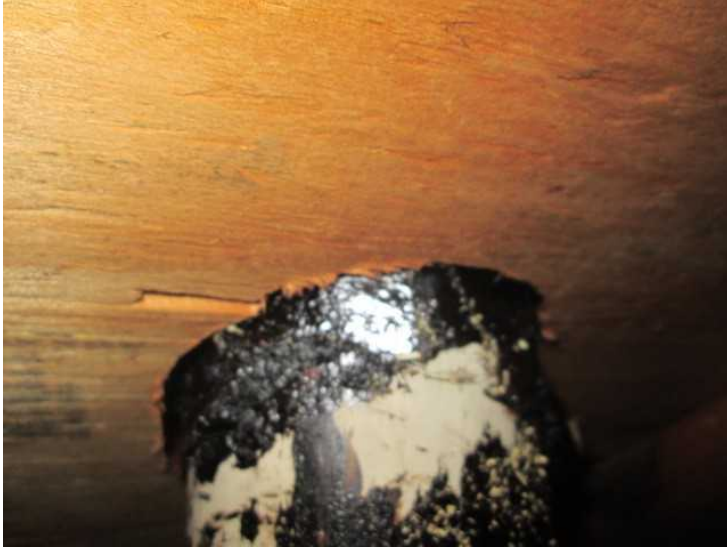
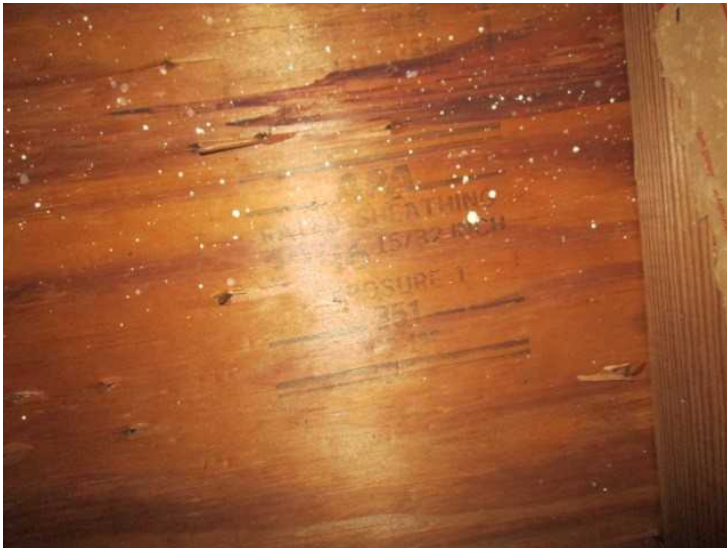
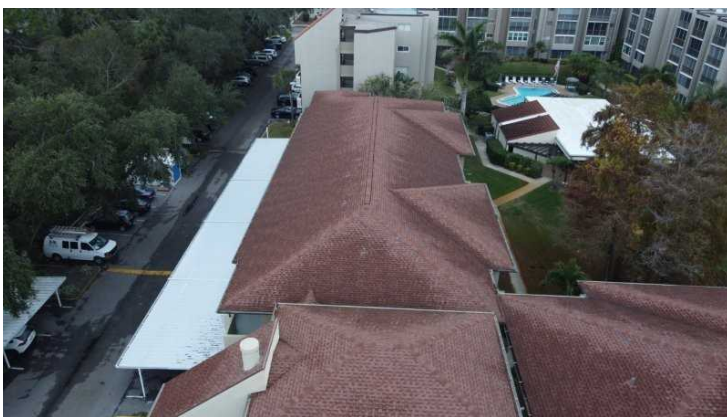
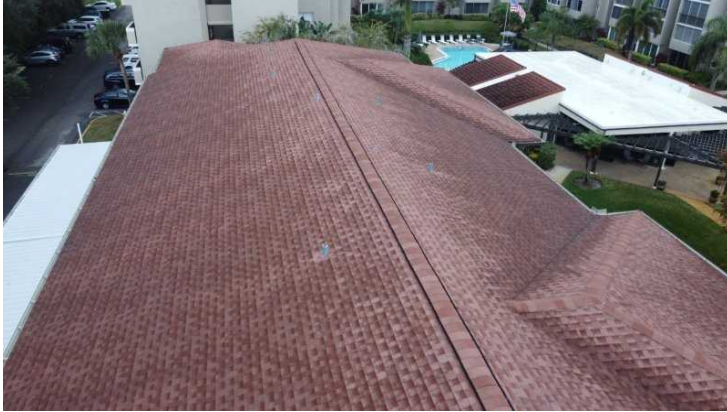
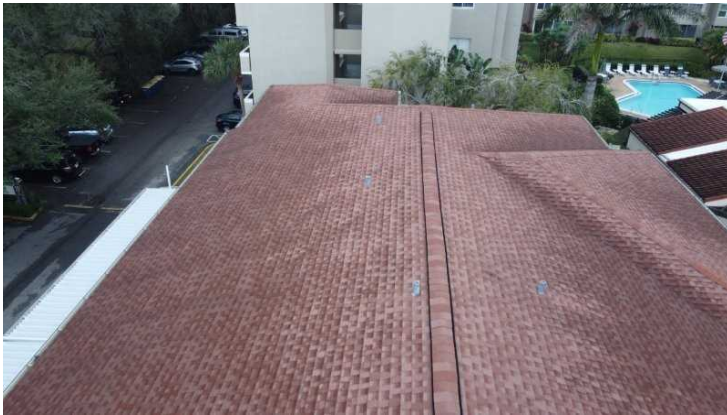
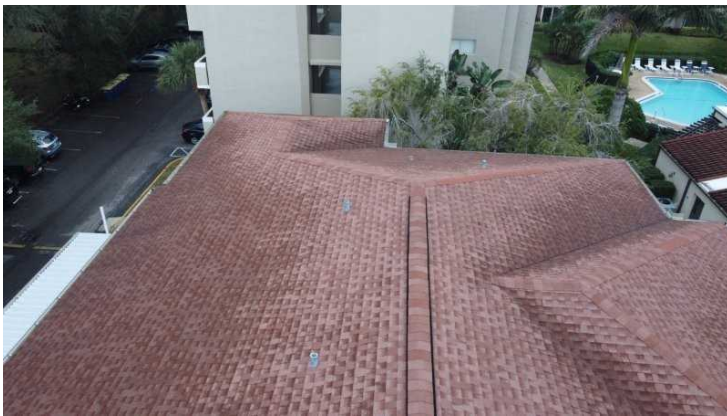
- 4. Roof to Wall Attachment:** **Clips**  
Comments: Inspection verified hurricane clips fastened with a minimum of three nails.
- 5. Roof Geometry:** **Hip Roof**  
Comments: Inspection verified a hip roof shape.

- 6. SWR:** **Yes**  
Comments: SWR was verified at time of inspection. The Secondary Water Resistance verified is a self-adhering peel and stick.
- 7. Opening Protection:** **None or Some Glazed Openings**  
Comments: No opening protection verified at the time of inspection.

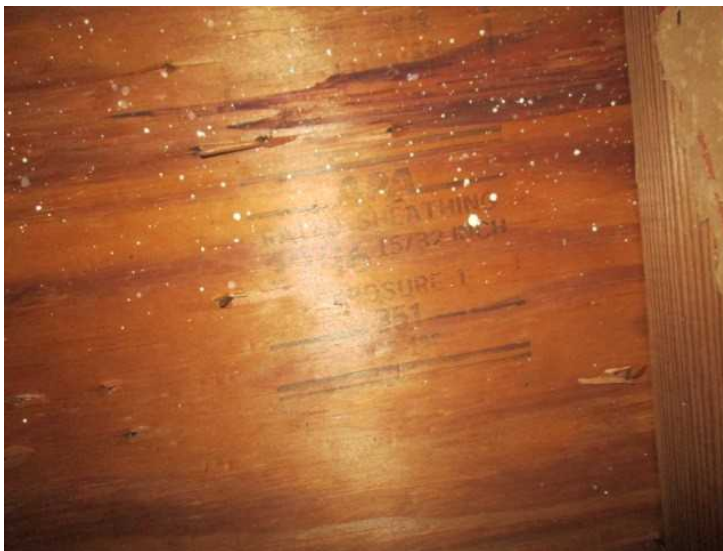
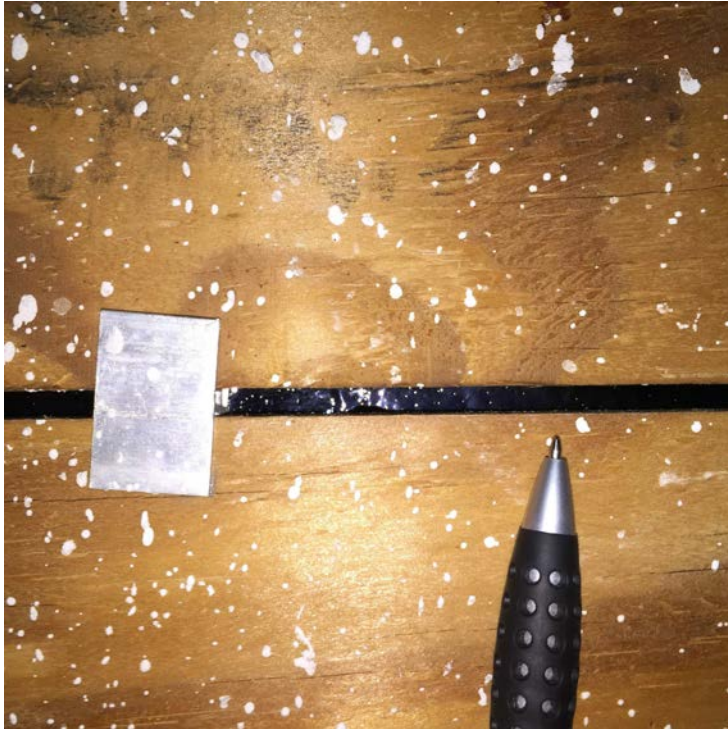
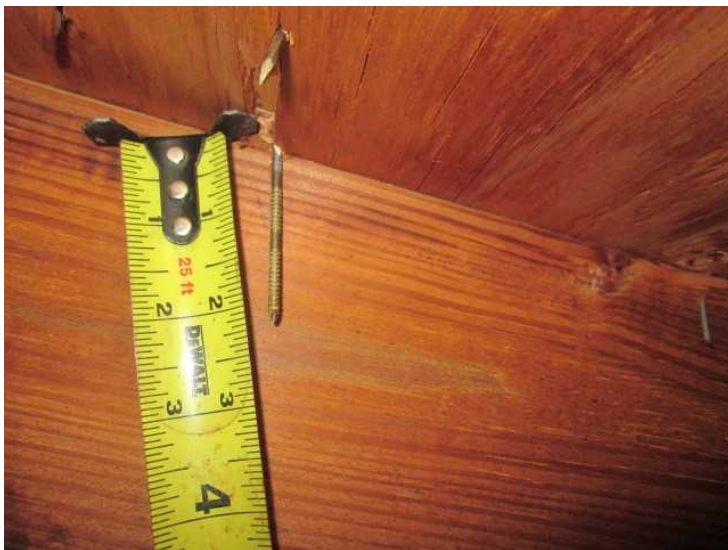
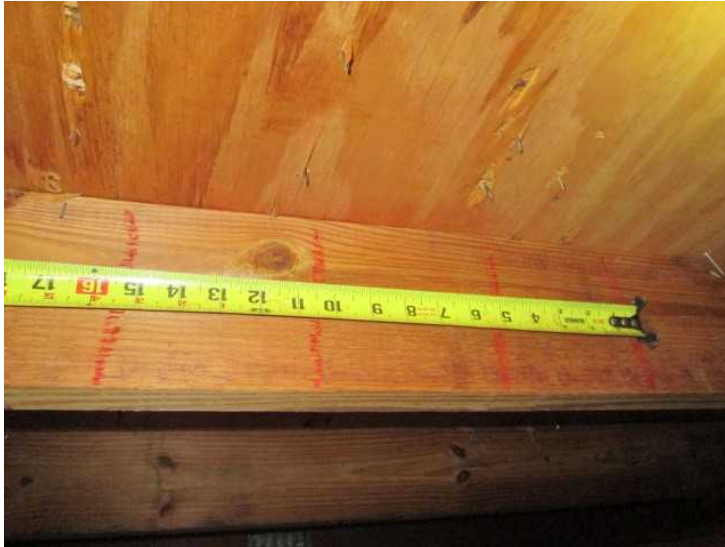
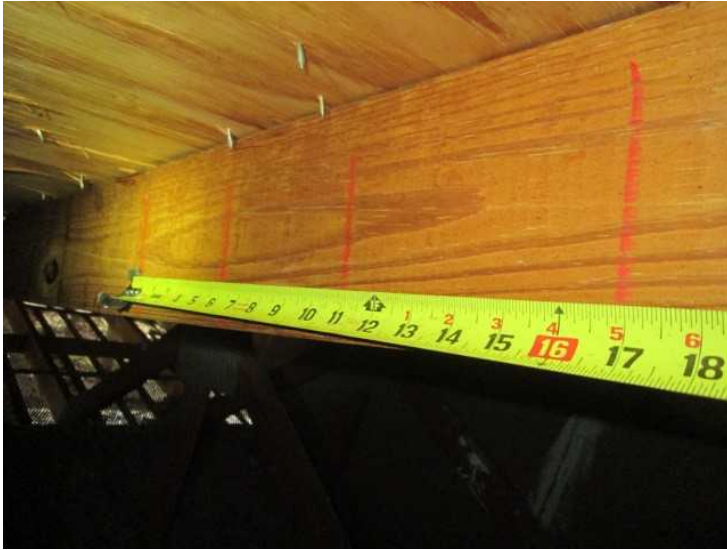
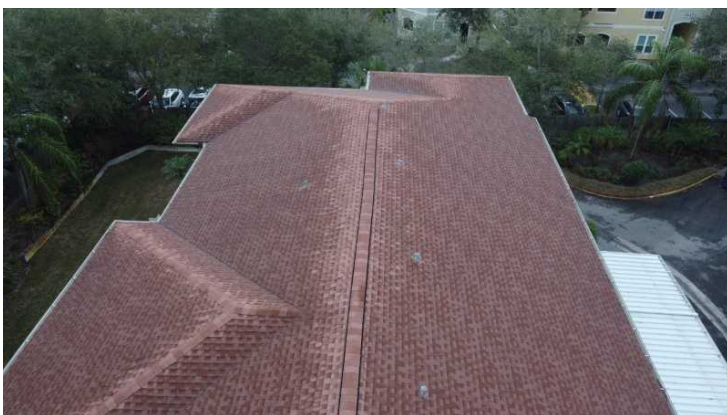
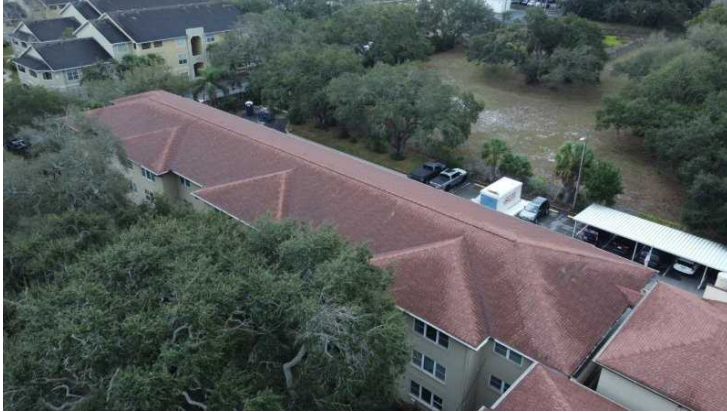
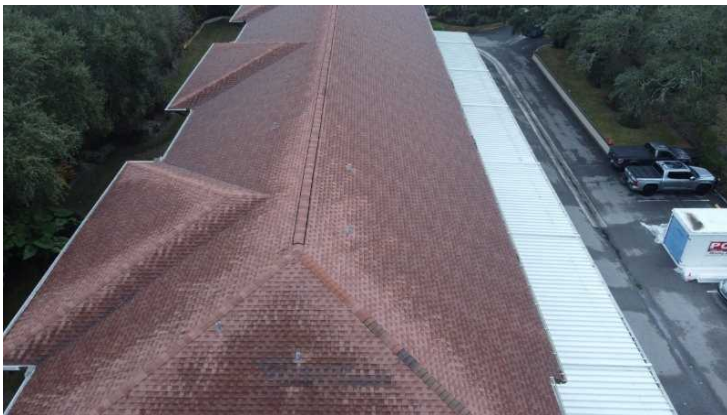
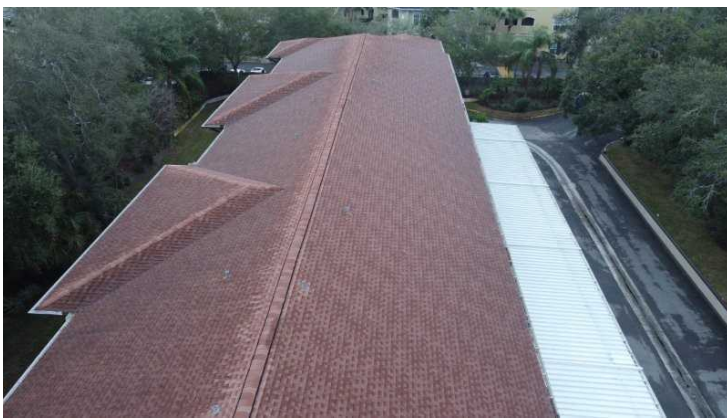
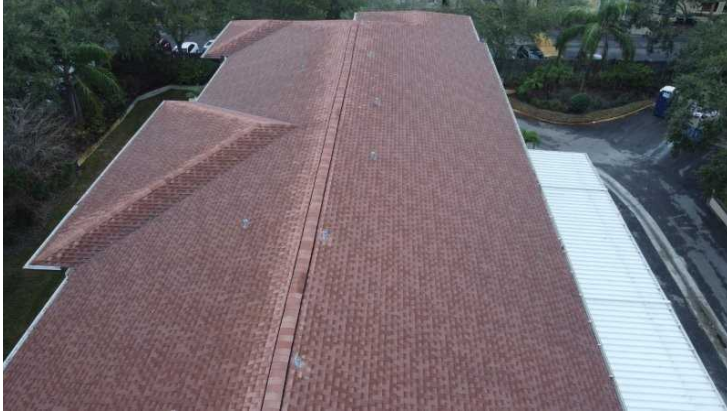
- 4. Roof to Wall Attachment:** **Clips**  
Comments: Inspection verified hurricane clips fastened with a minimum of three nails.
- 5. Roof Geometry:** **Hip Roof**  
Comments: Inspection verified a hip roof shape.

- 6. SWR:** **Yes**  
Comments: SWR was verified at time of inspection. The Secondary Water Resistance verified is a self-adhering peel and stick.
- 7. Opening Protection:** **None or Some Glazed Openings**  
Comments: No opening protection verified at the time of inspection.
